# Investigating the Causes of Sedimentation and Algal Blooms in Enka Lake, Candler, North Carolina

Cody McMechen  
Environmental Studies- Earth Science  
University of North Carolina Asheville  
One University Heights  
Asheville, North Carolina 28804 USA

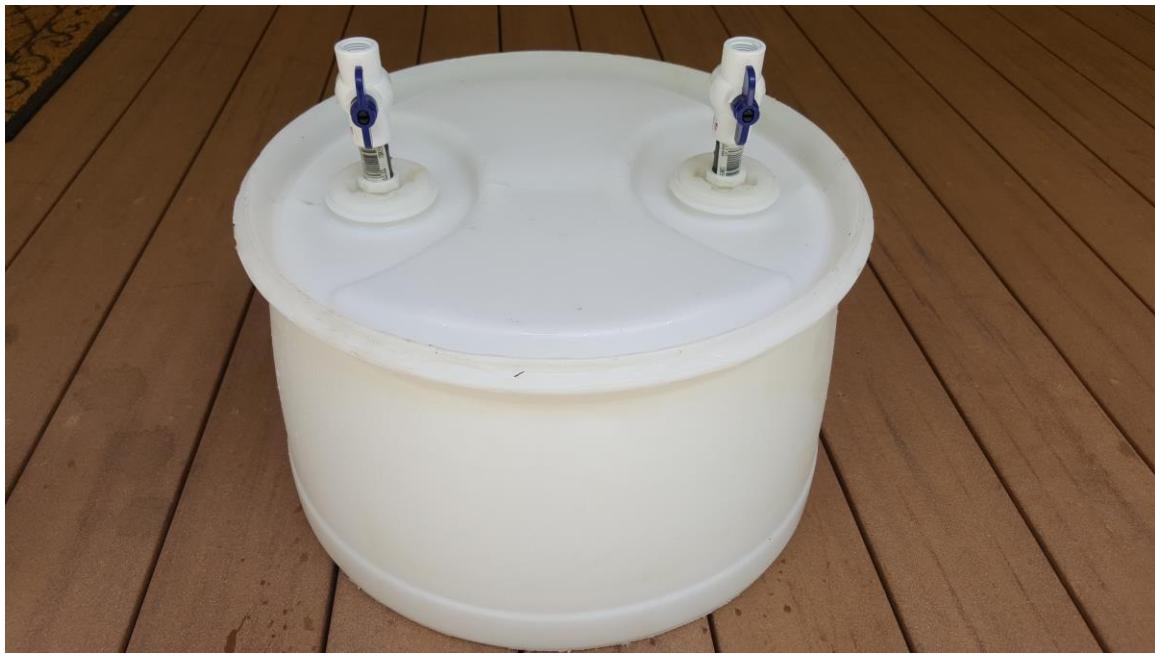
Figure 1. Seepage meter constructed to measure flow from lake bottom.

Groundwater discharge was measured by scuba diving to the bottom of the lake and inserting a seepage meter. The seepage meter was constructed using a 55-gallon plastic barrel. The barrel was cut in half and two valves were inserted on the top of one half (Figure 1). One valve allowed water to flow out of the seepage meter as it was being seated into the ground. The other valve was attached to a 2000-mL medical urine bag. For effective measurements, the seepage meter was inserted approximately 8-12 inches into the sediment on the bottom of the lake. Once properly seated, the second valve was opened to measure the volume of water that would either enter or exit the urine bag (and the bottom of the lake).

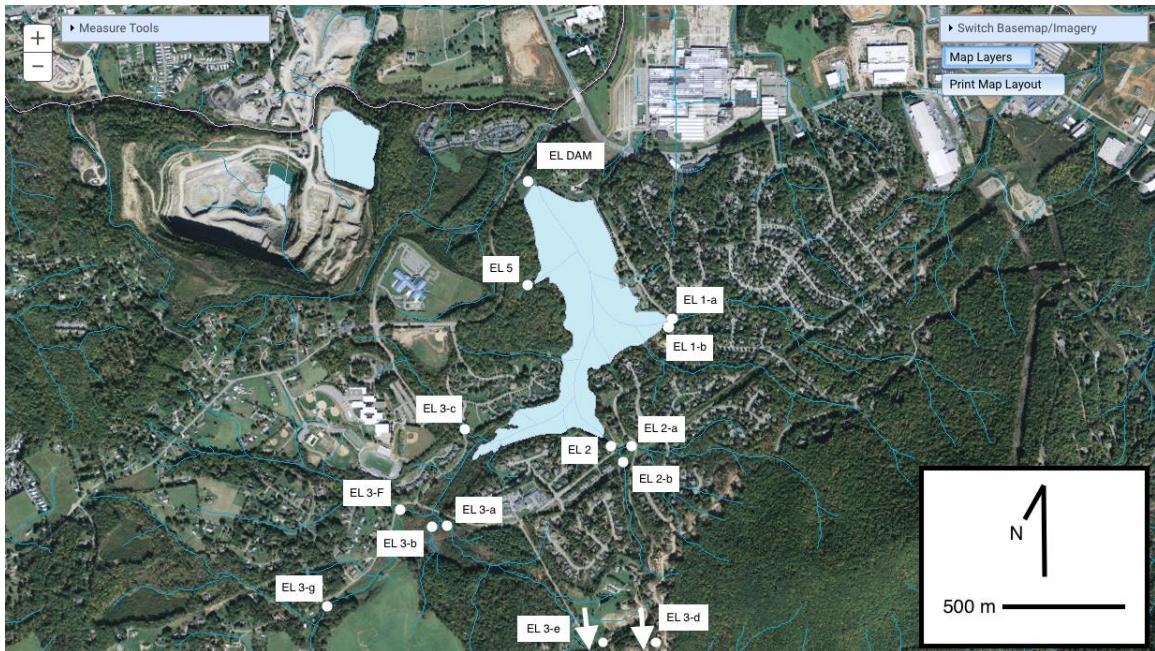
Figure 2a. Surface water sampling locations surrounding Enka Lake.

Surface water samples were collected from tributary streams leading into Enka Lake from February 2017 to July 2017 under baseflow and stormflow conditions. A grab sample was taken from each stream (shown in Figure 2a-b) and placed into a 500-mL plastic sample bottle. Each sample was refrigerated to limit growth of organisms that could occur between the time of sampling and analysis. At each tributary stream the turbidity, pH, temperature, and conductivity were measured, ensuring the stream was flowing where the measurements were taken.

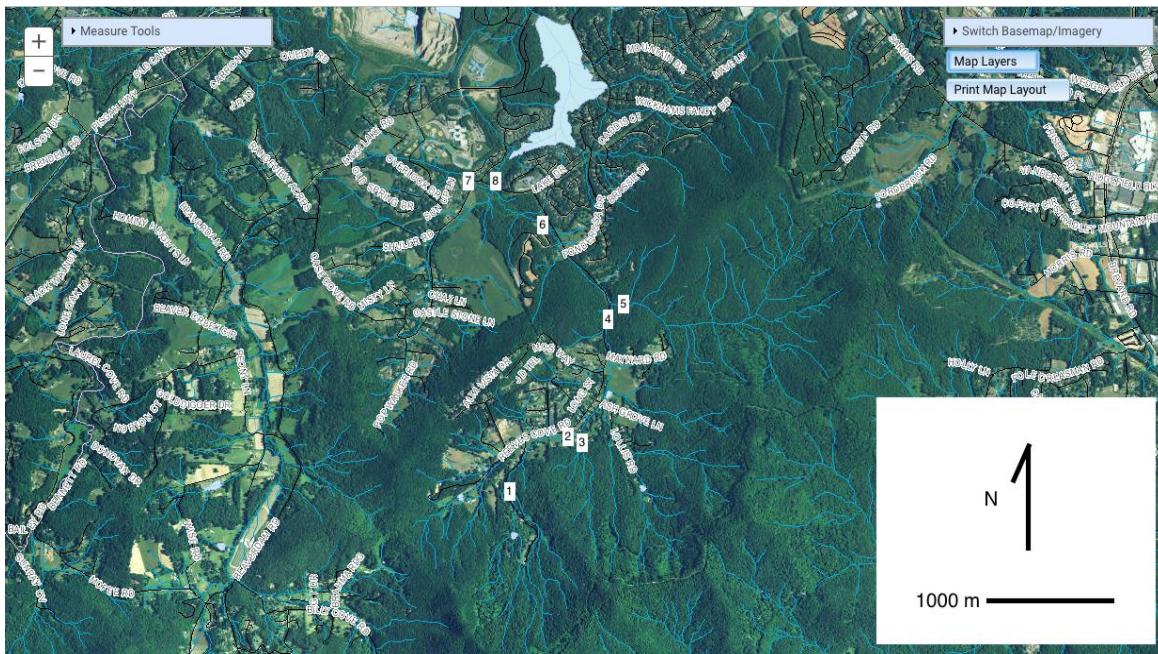
Figure 2b. Additional sampling sites for turbidity during stormflow conditions (collected by a local resident).

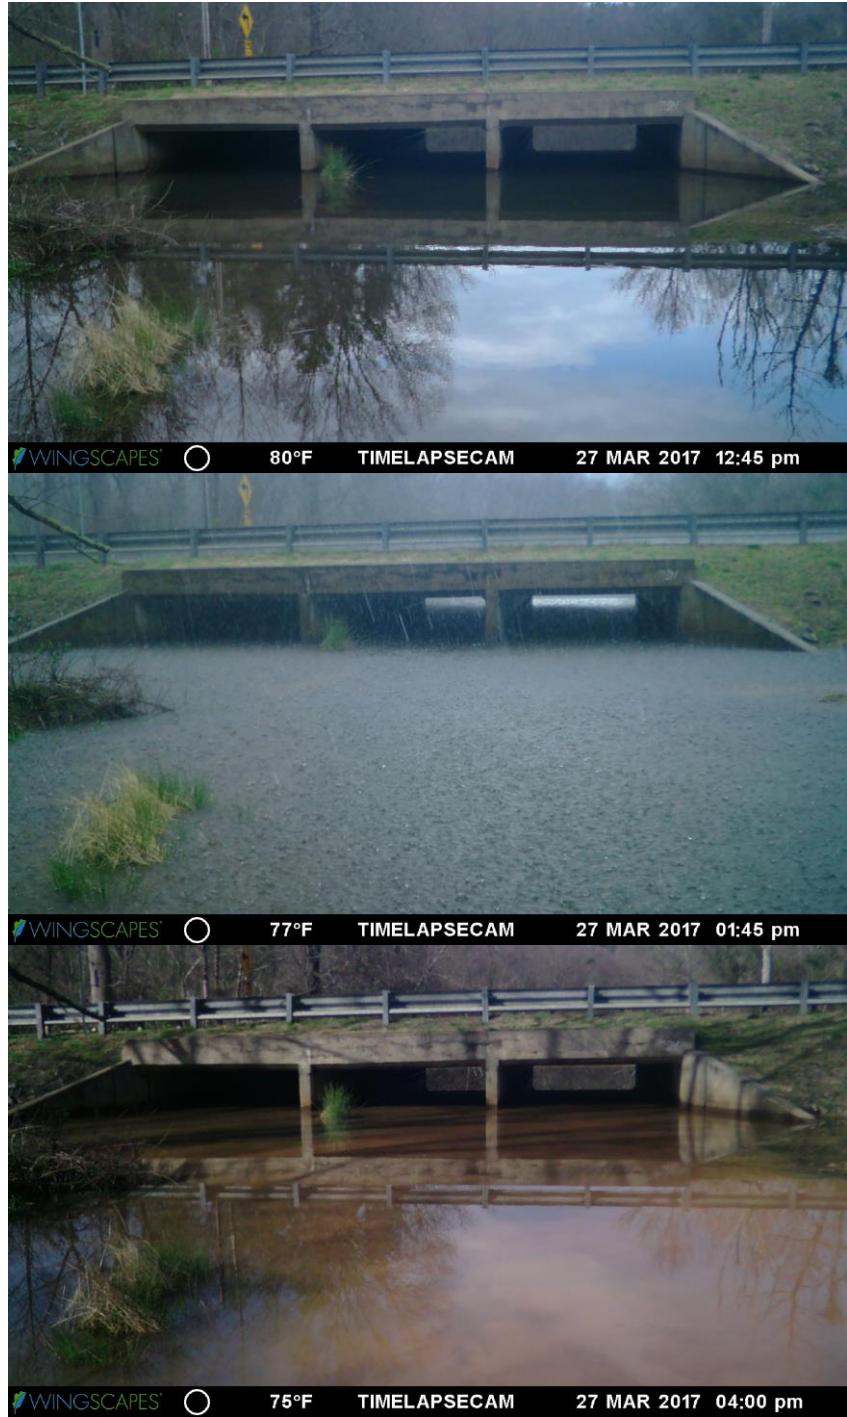
Figure 6. This time-lapse sequence shows the change in the color of the water before, during and after a storm event.

Turbidity measurements during baseflow conditions were very low but increased during stormflow conditions (Figure 5). The majority of the sediment was coming upstream from the EL 3-A. There were a few developments under construction that had bare soil that would easily be eroded. The overall color of the streams changed to rust orange, the color of the bare soil upstream (Figure 6).
