Analysis of a Recently Restored Appalachian Wetland

Emma Radulovic
Environmental Studies- Ecology and Biology
The University of North Carolina Asheville
One University Heights
Asheville, North Carolina 28804 USA

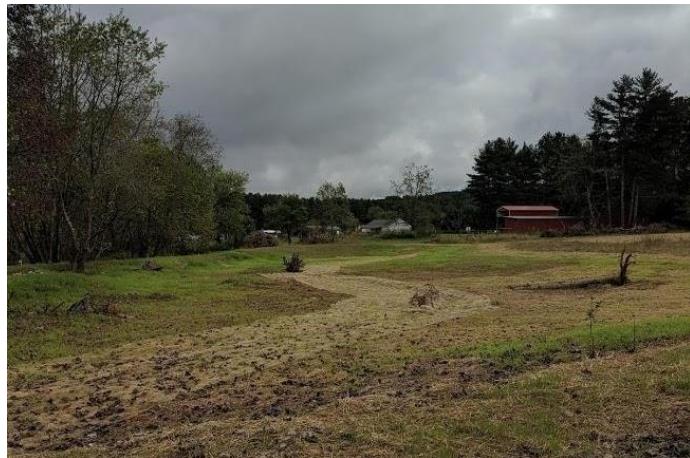
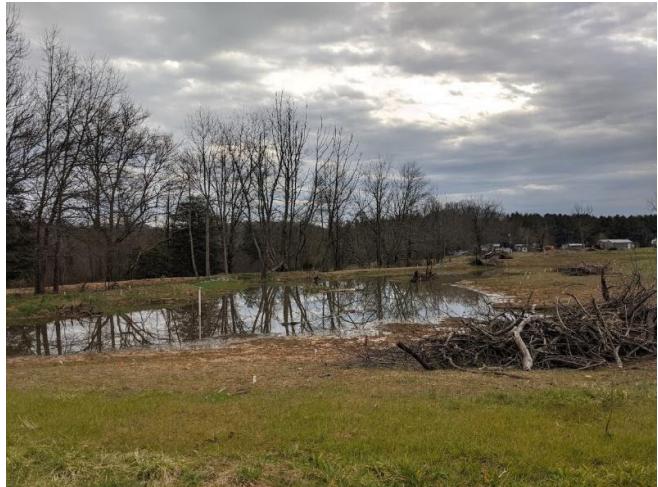
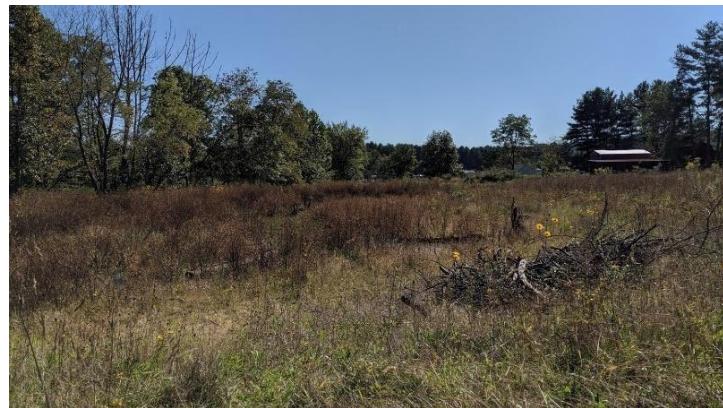
Figure 2 Pictures of Cell 1 post-construction Oct 2019, Mar 2020, and Oct 2020, respectively.

TNC's primary goals of the restoration project were to reduce runoff into the site and promote expansion of the wetland habitat. To do this, three retention cells were constructed upgradient of the bog to retain stormwater runoff during extreme flooding events. Native plant species such as rushes, sedges, and other herbaceous plants were planted around the holding cells to absorb and filter out excessive nutrients as the water infiltrates into the ground. Large tree stumps were put in the cells to help promote aquatic life and habitat (Figure 2).

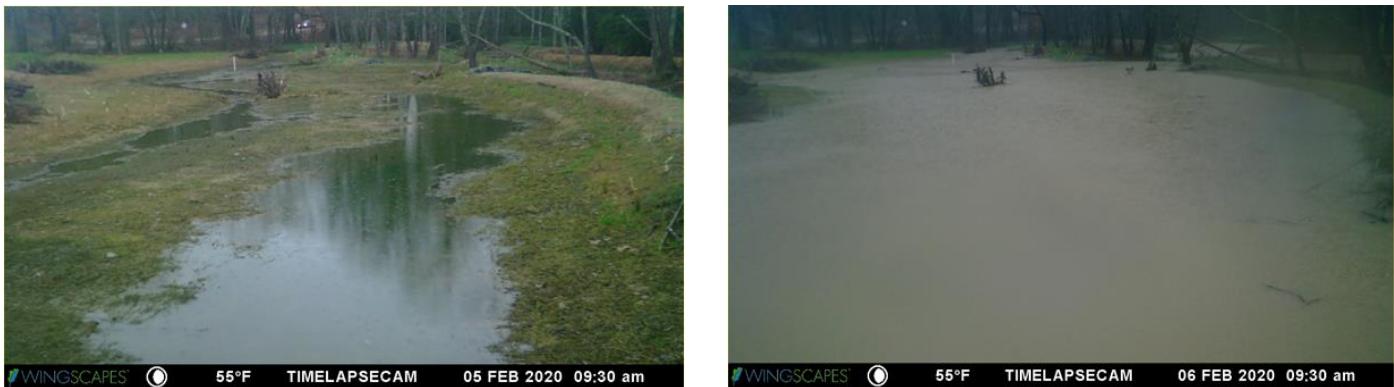
Figure 3 Images captured by a time-lapse camera showing the water level before the large rainstorm and during.

Sampling began in fall 2019 and continued until early spring 2020, until the COVID-19 pandemic limited further sampling until fall 2020. Site restoration was completed in November 2019, meaning there were three pre-completion sampling events, one at completion, and three after completion in spring and fall 2020. Most sampling events were during baseflow conditions, but one sampling event (2/6/2020) took place during peak stormflow (Figure 3).

Indications of a new stormflow path was observed on 2/6/2020. The large rain event caused all three cells to fill to max capacity and overflow. Behind Cell 3 there appeared to be a new channel that carried the excess runoff around the edge of the bog, away from the pitcher plants and toward an adjacent property.
