# **Landslide Hazards within the Spruce Pine 7.5-Minute Quadrangle: An Evaluation of Structural Controls on Bedrock Deterioration**

## **Abstract**

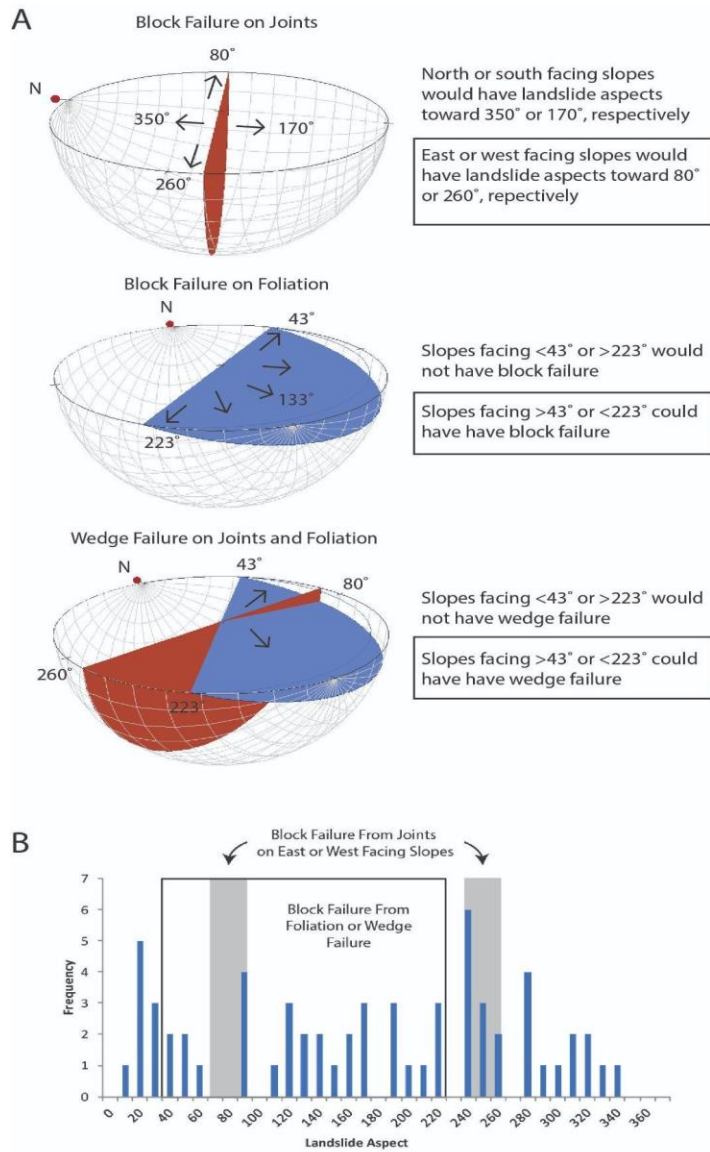
Figure 3: (A) Types of failures associated with landslide aspects. (B) Frequencies of landslide occurrences documented from this research.

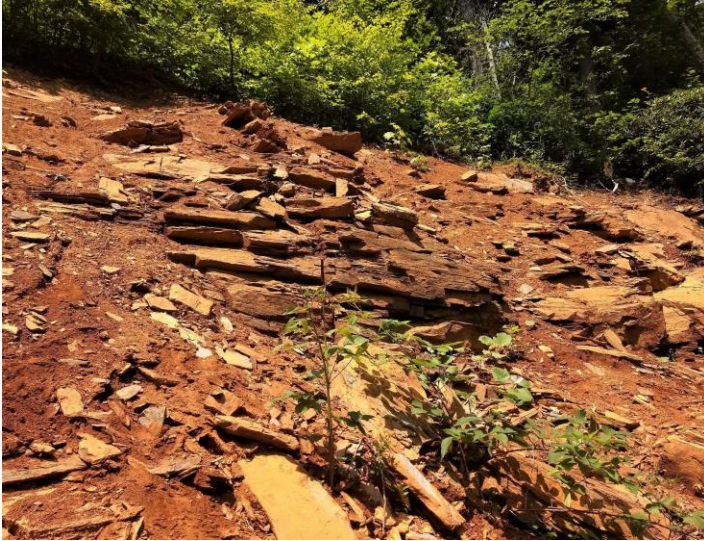
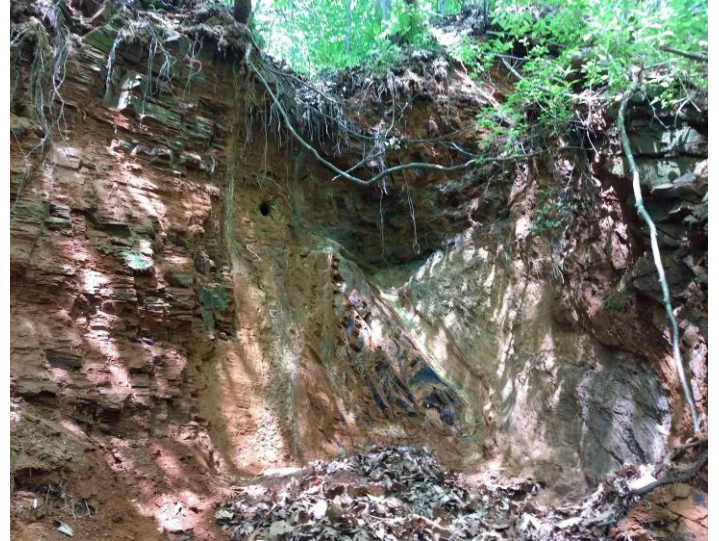
Figure 7: (A) Fractured and exposed bedrock becomes colluvial debris flow parallel to the Laurel Creek lineament. (B) Saprolite deposition influenced by hillside creep along the Laurel Creek lineament.

Orientations of fracture and foliation data within the study have been gathered from Palmer (2022) in order to understand the relationship between lineament fractures and landslide activity. In the stereonet, poles to joints and foliation are shown in color to give a representation of density within the quadrangle. Joint data ( $n=258$ ) are represented within the rose diagram and show a wide variety of directions (Fig. 4). The mean of the joint strikes are  $260.5^{\circ}/80.5^{\circ}$  which suggests a dominant east-west trend that aligns with the Laurel Creek lineament. Foliation data were also mapped and provided in a stereonet with ( $n=499$ ) and a dominant orientation of  $049^{\circ}/11^{\circ}$  with dip direction towards  $133^{\circ}$  (Fig. 5). The highest frequency of landslide activity ( $n=15$ ) occurred at aspects that were parallel to joint fabric. In the Beaver Creek area of Spruce Pine, NC lineament fractures are the origination of a landslide, which has moved due east and is parallel to strike (Fig. 6A and B). The direction of slope in the existing topography is uniformly distributed. However, landslides ( $\sim 28\%$ ) have shown the propensity to form on southeast dipping slopes in relation to foliation within the data set (Fig. 7A and B). Hillside creep further exposes bedrock (Fig. 8).

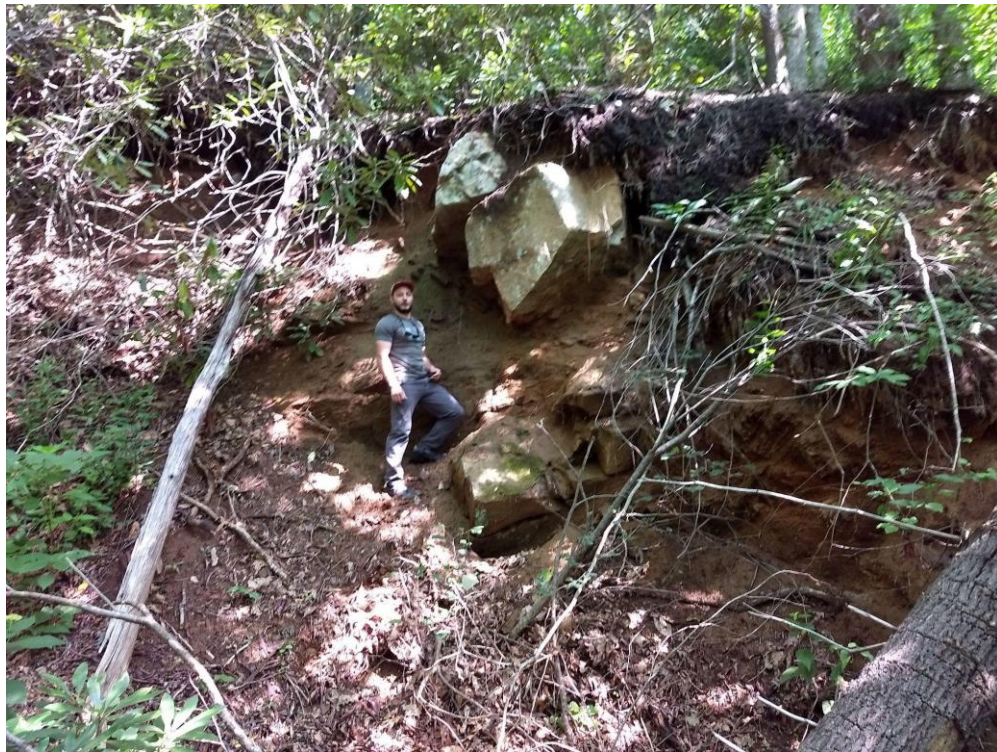
Figure 8. Toppled trees and bedrock breakdown associated with the effects of landslide mechanics.
