University of North Carolina Asheville Journal of Undergraduate Research Asheville, North Carolina Fall 2025

Monitoring Early Success of Small-Scale Riparian Zone Repair Post-Helene

Noah Ortiz

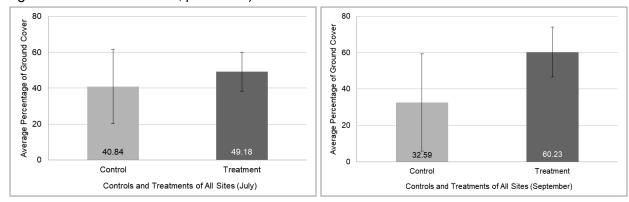
Figure 1. Comparison of the average percent covered ground of all control and treatment sites with standard deviations. a. (left) July 2025 data collection; b. (right) September 2025 data collection. (Overall Wilcoxon signed-rank test: W = 27.0, p = 0.002).

had the largest difference between control and treatment sites, with approximately 30% more covered ground in their treatment sites. Baird Cove was the only site in which the control had more ground cover than the treatment, with a difference of 23.63%. However, there was no significant difference between the control and treatment across sites in July (Wilcoxon signed-rank test: W = 41.0, p = 0.093). In September, all treatment sites had significantly higher percentages of ground cover (Wilcoxon signed-rank test: W = 52.0, p = 0.007), with the greatest difference being at Rhododendron and Willow. Across all months, sites, and treatments, there was significantly more ground cover on treated sites than control sites (Fig. 1) (Wilcoxon signed-rank test: W = 27.0, p = 0.002).

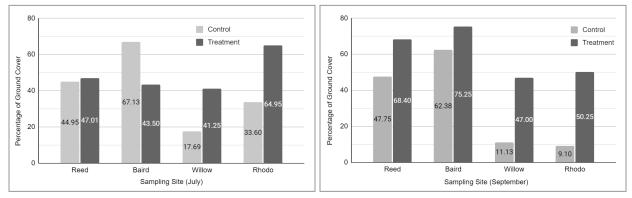
Figure 2. Comparison of the percent covered ground for the control and treatment sites across all sites. a. (left) July 2025 data collection; b. (right) September 2025 data collection.

Willow, Rhododendron, and Reed treatment sites all had a higher percentage of ground cover than the control in both July and September (Fig. 2). In July, Willow and Rhododendron

Three out of four treatment sites had a greater percentage of ground cover than their corresponding controls in July (Fig. 2). This suggests that there was initial success in the establishment of vegetation during repair. In July, the Baird Cove control site had more covered ground than its corresponding treatment, however, by September the treatment had surpassed the control. In September, all treatment sites had significantly more covered ground than their corresponding controls, indicating that near the end of the first growing season, repaired sites will have increased vegetative cover. From July to September, all control sites showed a decrease in ground cover except for Reed. This may be explained by the rapid growth rates of non-native invasive species; once present, these plants are proficient at spreading throughout a landscape, resulting in a greater vegetative cover that may actually cause harm as slower-growing native species are outcompeted. All treatment sites showed an increase in ground cover between data collections, except for Rhododendron. Rhododendron's decrease in ground cover may be explained by its proximity to residential properties, which often leach pollutants such as herbicide and vehicle emissions.

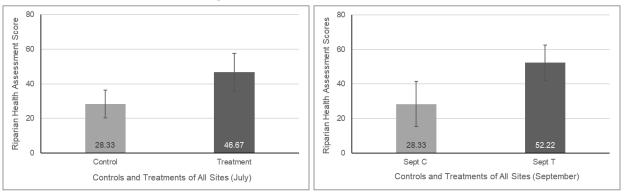
Figure 3. Riparian Health Assessment scores as an average percentage of all control and treatment sites with standard deviations. a. (left) July 2025 data collection; b. (right) September 2025 data collection. (Overall Wilcoxon signed-rank test: W = 10.0, p = 0.05).

The Riparian Health Assessment scores were consistently higher at all treatment sites than control sites for July and September (Fig. 3). The largest difference occurred at Reed, and the smallest at Willow for both data collection periods (Fig. 4). July had significantly higher RHA scores for treatment sites than control sites (Wilcoxon signed-rank test: W = 10.0, p = 0.05), as well as September (Wilcoxon signed-rank test: W = 10.0, p = 0.05). Data analysis over both months showed that overall, treatment sites had significantly higher RHA scores (Wilcoxon signed-rank test: W = 10.0, p = 0.05). Willow, Rhododendron, and Baird treatment sites showed an increase in scores from July to September, while Reed decreased (Fig. 4). Reed and Baird

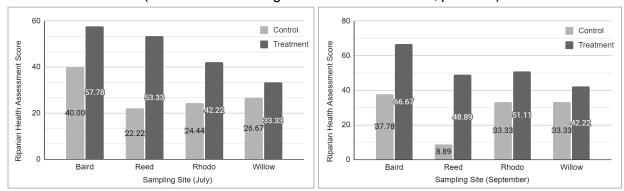
Figure 4. Riparian Health Assessment scores as a percentage for the control and treatment sites across all sites. a. (left) July 2025 data collection; b. (right) September 2025 data collection.

controls showed a decrease in scores between data collection periods, while Rhododendron and Willow controls increased (Fig. 4).

For every site sampled, the Riparian Health Assessment score was higher at the treated site than the control site (Fig. 4). Both months showed a significantly higher score in the treatment, with three out of four treated sites showing an increase in scores between July and September. This suggests that repaired streambanks will maintain and continue to develop higher functioning ecosystems post-repair throughout the first growing season, while untreated sites are more vulnerable to slow or even decreased functioning as seen at Reed Creek between data collection periods. The Reed control site consistently had the lowest score; this aligns with the fact that urbanized streams face more degradation, meaning that hydrologic flashiness, compacted soils, and nutrient loading limit the establishment of native seedlings (Juan-Diego et al., 2025). Such streambanks may struggle to recover in the absence of ecosystem-focused repair. It is important to note that in July, all sites fell within the non-functioning range (<60%); in September, the Baird treatment had a score in the functioning-at-risk category (60-79%) (Fitch et al., 2009). Baird had the highest scores across control and treatment, suggesting that it may have been higher functioning, and therefore better equipped to support vegetation, prior to repair. Overall, heightened RHA scores at treated sites indicate not only structural recovery (e.g., canopy cover, root mass stability) but also early signs of improved ecosystem function, such as reduced bank erosion potential and healthier vegetative species composition. Continued monitoring is needed to determine whether these trends persist or plateau as vegetation matures and the ecosystem stabilizes.
